**Flood Control Project Maintenance  
Levee Inspections**

## Maintenance Issue Types Only, Levee Inspection Report By Mile - Spring 2019

### Reclamation District No. 0524 Middle Roberts Island

Waterway	Bank	Unit Miles	Inspection Start/End	Inspector
Unit No. 01 San Joaquin River	Left	6.20	03/26/2019 03/27/2019	Alberto De Leon

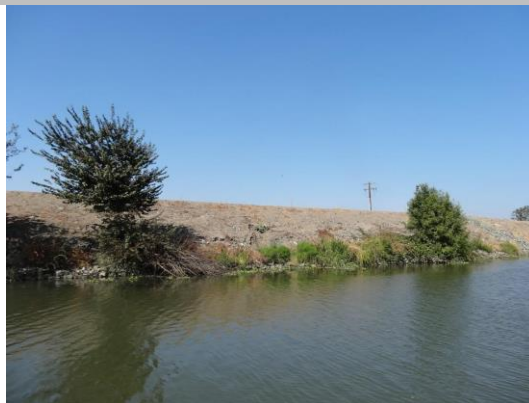
Photo 2 of 3 : SP\_2019\_RD0524\_107\_56\_20190313\_00078.jpg

LM Start	1.39	Rating **	U	Issue No.	56 (cont)	
LM End	1.39	Issue Type +	Ma	Location *	WS	
Category	Supplemental			GPS Latitude/Longitude		
				Start	End	
Item	DWR Erosion Survey			37.930575	°	37.930575
				-121.328090	°	-121.328090
DWR ID	RD0524U01RM42.03					
Comment Code						
Inspector Comment						
09/13/2017: No significant change observed 07/25/2016: No significant change observed 06/24/2015: No significant change observed. 06/19/2014: No significant change observed. 08/13/2013: No significant change observed. 08/07/2012: The site was first reported in 2012 spring levee inspection report. The site is located about 750 ft downstream of SR 4 Bridge. [2017 Site ID:RD0524U01RM42.03]

Front view of the erosion.

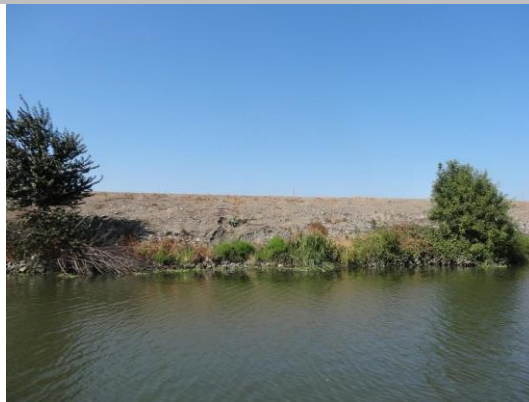
Photo 3 of 3 : SP\_2019\_RD0524\_107\_56\_20190313\_00079.jpg

Close view of the erosion.

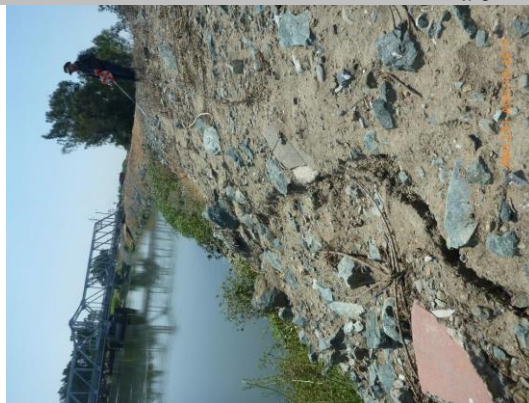
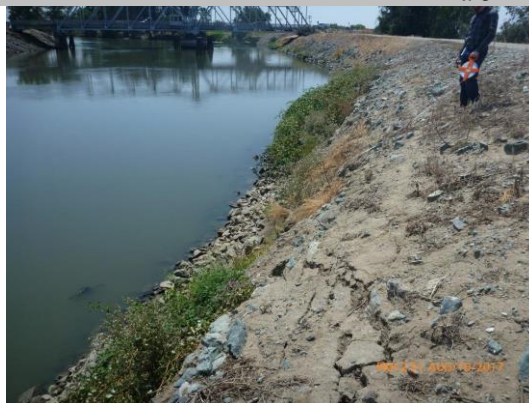
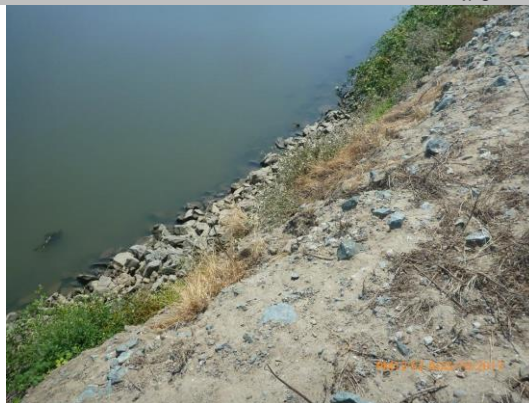
LM Start	1.43	Rating **	A/W	Issue No.	226
LM End	1.44	Issue Type +	Ma	Location *	
Category	Supplemental			GPS Latitude/Longitude	
				Start	End
Item	2017 Storm Damage			37.930100 °	37.929900 °
				-121.328300 °	-121.328300 °
DWR ID	DWR_RD0524_01_f_2017_226				
Comment Code					
Inspector Comment					
Levee Evaluation Comments					
Description:Slope protection repairs are needed along the waterside slope due to erosion and riprap displacement from high water. Based upon levee inspections, it was determined the waterside levee slope is eroding, deteriorating, and degrading. The eroded levee sections need to be restored back to design standards to prevent further deterioration and damage.					
Site ID No:530					
Site Designation:LMA-436					
Repair Type: Erosion					
Rating:Area of Concern					
Field Date:8/10/2017					
Notes:

LM Start	1.43	Rating **	A/W	Issue No.	226 (cont)
LM End	1.44	Issue Type +	Ma	Location *	
Category	Supplemental			GPS Latitude/Longitude	
				Start	End
Item	2017 Storm Damage			37.930100 °	37.929900 °
				-121.328300 °	-121.328300 °
DWR ID	DWR_RD0524_01_f_2017_226				
Comment Code					
Inspector Comment					
Levee Evaluation Comments					
Description:Slope protection repairs are needed along the waterside slope due to erosion and riprap displacement from high water. Based upon levee inspections, it was determined the waterside levee slope is eroding, deteriorating, and degrading. The eroded levee sections need to be restored back to design standards to prevent further deterioration and damage.					
Site ID No:530					
Site Designation:LMA-436					
Repair Type: Erosion					
Rating:Area of Concern					
Field Date:8/10/2017					
Notes:

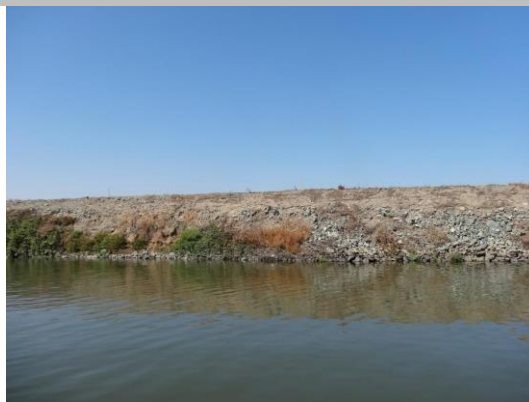
Photo 1 of 4 : SP\_2019\_RD0524\_107\_60\_20190313\_00083.jpg

LM Start	1.45	Rating **	U	Issue No.	60
LM End	1.47	Issue Type +	Ma	Location *	WS
Category	Supplemental			GPS Latitude/Longitude	
				Start	End
Item	DWR Erosion Survey			37.929650 °	37.929650 °
				-121.328110 °	-121.328110 °
DWR ID	RD0524U01RM42.09				
Comment Code					
Inspector Comment					
09/13/2017: No significant change observed.					
07/25/2016: No significant change observed.					
06/24/2015: No significant change observed.					
06/19/2014: No significant change observed.					
08/13/2013: The site is located approximately 400 ft. downstream SR 4					
Bridge. Dense vegetation is visible at the toe. [2017 Site					
ID:RD0524U01RM42.09]

Front view of the erosion site.

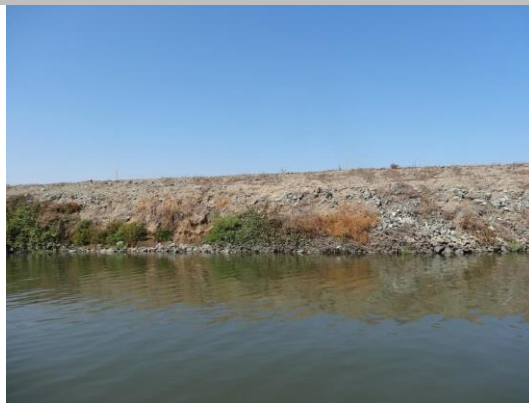
Photo 2 of 4 : SP\_2019\_RD0524\_107\_60\_20190313\_00084.jpg

LM Start	1.45	Rating **	U	Issue No.	60 (cont)	
LM End	1.47	Issue Type +	Ma	Location *	WS	
Category	Supplemental			GPS Latitude/Longitude		
				Start	End	
Item	DWR Erosion Survey			37.929650 °	37.929650 °	
				-121.328110 °	-121.328110 °	
DWR ID	RD0524U01RM42.09					
Comment Code						
Inspector Comment						
09/13/2017: No significant change observed.						
07/25/2016: No significant change observed.						
06/24/2015: No significant change observed.						
06/19/2014: No significant change observed.						
08/13/2013: The site is located approximately 400 ft. downstream SR 4 Bridge. Dense vegetation is visible at the toe. [2017 Site ID:RD0524U01RM42.09]

Front view of the erosion.

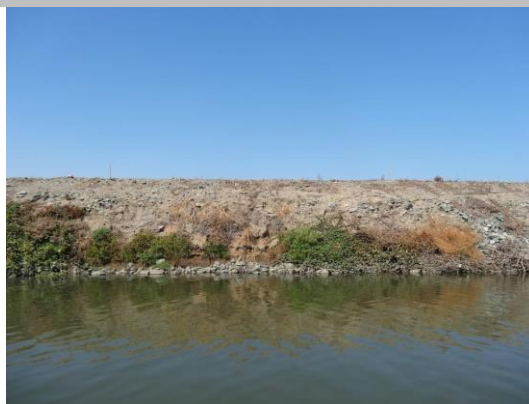
Photo 3 of 4 : SP\_2019\_RD0524\_107\_60\_20190313\_00085.jpg

Close view of the erosion. Note the vegetation at the site.

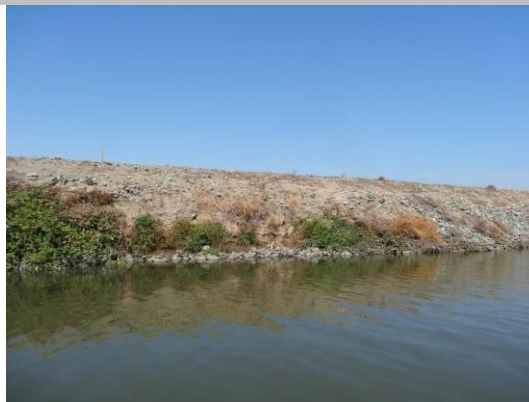
Photo 4 of 4 : SP\_2019\_RD0524\_107\_60\_20190313\_00086.jpg

Close view of the erosion.

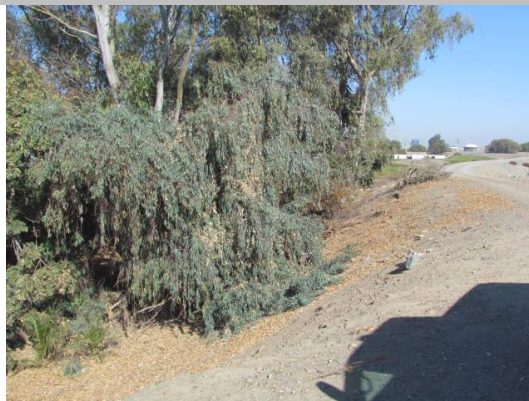
Photo 1 of 1 : SP\_2019\_RD0524\_107\_916\_20190313\_00285.jpg

LM Start	1.49	Rating **	U	Issue No.	916
LM End	1.49	Issue Type +	Ma	Location *	LS
Category	Earthen Levee			GPS Latitude/Longitude	
				Start	End
Item	Trim / Thin Trees			37.929118 °	37.929118 °
				-121.328368 °	-121.328368 °
DWR ID	DWR_RD0524_01_s_2012_916				
Comment Code					
T3 : Trim and thin trees to allow visibility of the ground and room to flood fight.					
Inspector Comment					
Untrimmed trees and dense vegetation on landside toe.

Looking at dense trees on landward slope and toe fall 2015

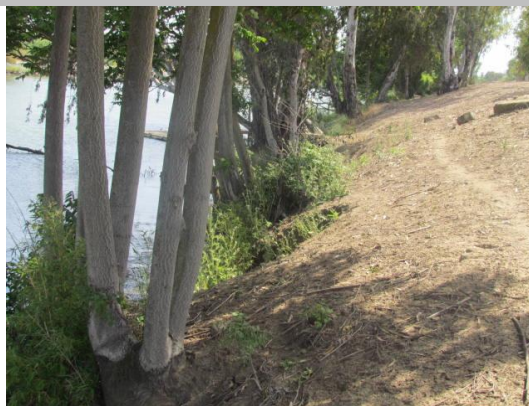
Photo 1 of 3 : SP\_2019\_RD0524\_107\_26\_20190313\_00039.jpg

LM Start	1.62	Rating **	M	Issue No.	26
LM End	1.64	Issue Type +	Ma	Location *	WS
Category	Earthen Levee			GPS Latitude/Longitude	
				Start	End
Item	Erosion / Bank Caving			37.927507 °	37.927295 °
				-121.327593 °	-121.327298 °
DWR ID	DWR_RD0524_01_s_2012_26				
Comment Code					
E1 : Note and monitor erosion site.					
Inspector Comment					
Several erosions along this reach.

Looking south at waterward erosion.

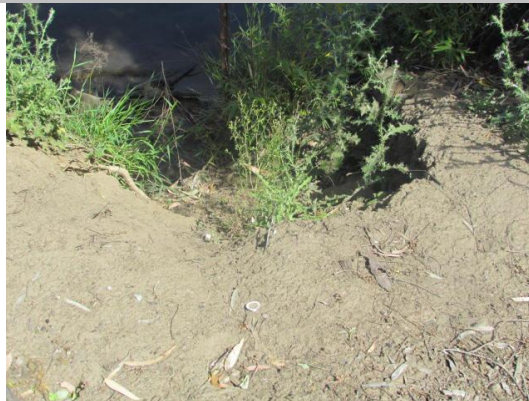
Photo 2 of 3 : SP\_2019\_RD0524\_107\_26\_20190313\_00040.jpg

Looking east at waterward erosion.

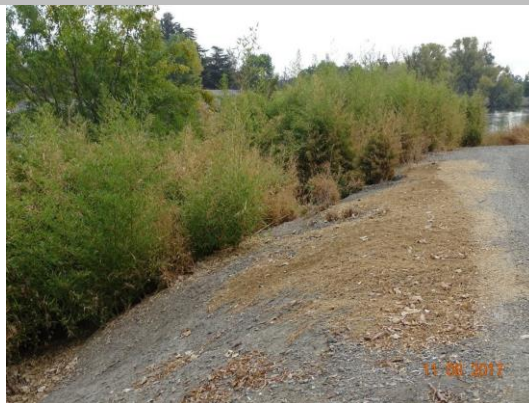
Photo 1 of 1 : SP\_2019\_RD0524\_107\_243\_20190313\_00263.jpg

LM Start	1.71	Rating **	U	Issue No.	243
LM End	1.72	Issue Type +	Ma	Location *	WS
Category	Earthen Levee			GPS Latitude/Longitude	
				Start	End
Item	Vegetation			37.926638 °	37.926471 °
				-121.326374 °	-121.326175 °
DWR ID	DWR_RD0524_01_f_2017_243				
Comment Code					
V2 : Remove the wild growth other than native grasses from the levee slopes.					
Inspector Comment

Looking southeast at the waterside slope.

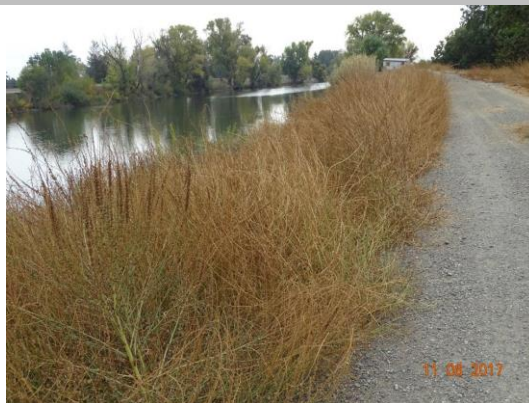
Photo 1 of 1 : SP\_2019\_RD0524\_107\_244\_20190313\_00264.jpg

LM Start	1.73	Rating **	M	Issue No.	244
LM End	1.75	Issue Type +	Ma	Location *	WS
Category	Earthen Levee			GPS Latitude/Longitude	
				Start	End
Item	Vegetation			37.926395 °	37.926191 °
				-121.326125 °	-121.325952 °
DWR ID	DWR_RD0524_01_f_2017_244				
Comment Code					
V2 : Remove the wild growth other than native grasses from the levee slopes.					
Inspector Comment

Looking southeast at the waterside slope.

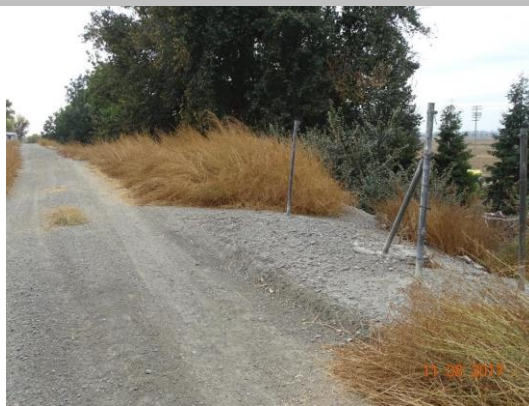
Photo 1 of 1 : SP\_2019\_RD0524\_107\_245\_20190313\_00265.jpg

LM Start	1.73	Rating **	U	Issue No.	245
LM End	1.75	Issue Type +	Ma	Location *	LS
Category	Earthen Levee			GPS Latitude/Longitude	
				Start	End
Item	Vegetation			37.926312 °	37.926093 °
				-121.326065 °	-121.325864 °
DWR ID	DWR_RD0524_01_f_2017_245				
Comment Code					
V2 : Remove the wild growth other than native grasses from the levee slopes.					
Inspector Comment

Looking southeast at the landside slope.

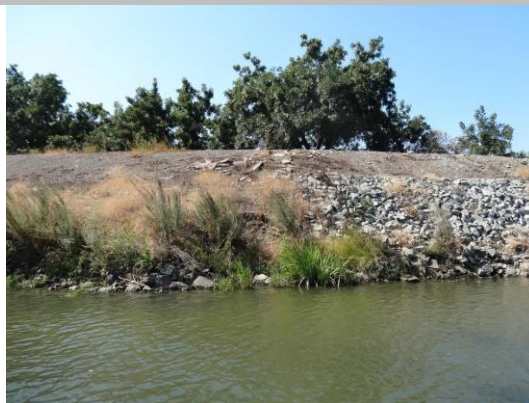
Photo 1 of 3 : SP\_2019\_RD0524\_107\_70\_20190313\_00095.jpg

LM Start	2.30	Rating **	M	Issue No.	70
LM End	2.30	Issue Type +	Ma	Location *	WS
Category	Supplemental			GPS Latitude/Longitude	
				Start	End
Item	DWR Erosion Survey			37.920150 °	37.920150 °
				-121.319700 °	-121.319700 °
DWR ID	RD0524U01RM42.9				
Comment Code					
Inspector Comment					
09/13/2017: The erosion is located immediately upstream of a repaired levee section. [2017 Site ID:RD0524U01RM42.9]

Front view of the pocket erosion.

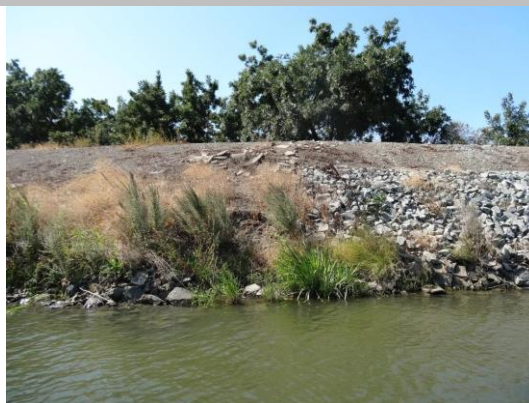
Photo 2 of 3 : SP\_2019\_RD0524\_107\_70\_20190313\_00096.jpg

Close view of the erosion.

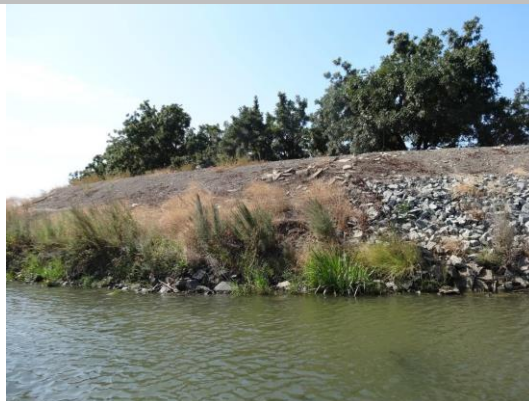
Photo 3 of 3 : SP\_2019\_RD0524\_107\_70\_20190313\_00097.jpg

Front view of the erosion.

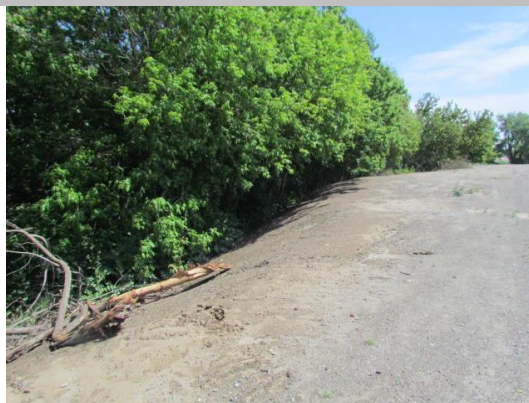
Photo 1 of 1 : SP\_2019\_RD0524\_107\_185\_20190313\_00187.jpg

LM Start	2.60	Rating **	M	Issue No.	185
LM End	2.64	Issue Type +	Ma	Location *	WS
Category	Earthen Levee			GPS Latitude/Longitude	
				Start	End
Item	Trim / Thin Trees			37.917152 °	37.916807 °
				-121.322582 °	-121.322069 °
DWR ID	DWR_RD0524_01_s_2014_185				
Comment Code					
T2 : Thin trees to allow visibility of the ground and room to flood fight.					
Inspector Comment

Looking northwest at untrimmed trees on landward slope and toe.

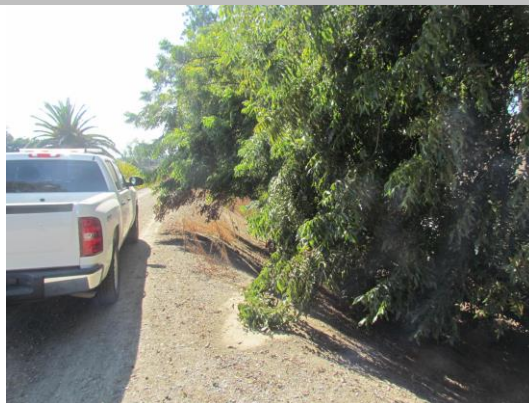
Photo 1 of 2 : SP\_2019\_RD0524\_107\_264\_20190313\_00277.jpg

LM Start	2.72	Rating **	M	Issue No.	264
LM End	2.76	Issue Type +	Ma	Location *	LS
Category	Earthen Levee			GPS Latitude/Longitude	
				Start	End
Item	Trim / Thin Trees			37.915698 °	37.915304 °
				-121.322498 °	-121.322763 °
DWR ID	DWR_RD0524_01_s_2012_264				
Comment Code					
T2 : Thin trees to allow visibility of the ground and room to flood fight.					
Inspector Comment					
Untrimmed trees along landside slope and toe. Additionally, trim over hanging trees at least 12 feet above ground level.

Looking south at untrimmed trees on landward slope.

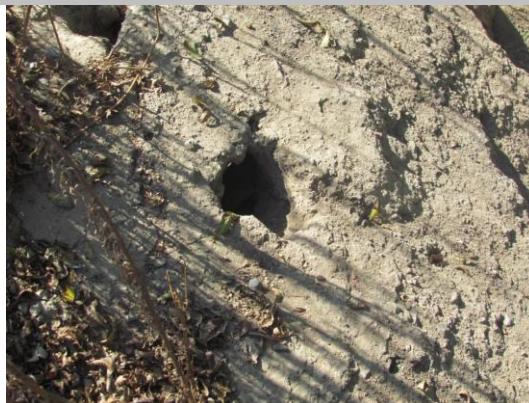
Photo 1 of 2 : SP\_2019\_RD0524\_107\_219\_20190313\_00220.jpg

LM Start	2.77	Rating **	U	Issue No.	219
LM End	2.80	Issue Type +	Ma	Location *	LS
Category	Earthen Levee			GPS Latitude/Longitude	
				Start	End
Item	Animal Control			37.915195 °	37.915052 °
				-121.322930 °	-121.323430 °
DWR ID	DWR_RD0524_01_f_2016_219				
Comment Code					
A1 : Exterminate rodents and backfill and compact or grout burrows.					
Inspector Comment					
Several large rodent holes on landside slope.

Looking at typical rodent hole on waterward slope.

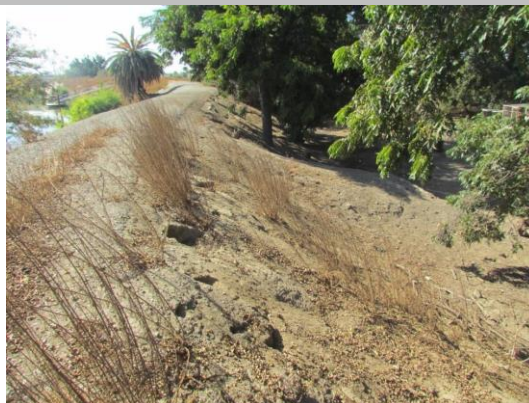
Photo 2 of 2 : SP\_2019\_RD0524\_107\_219\_20190313\_00221.jpg

LM Start	2.77	Rating **	U	Issue No.	219 (cont)	
LM End	2.80	Issue Type +	Ma	Location *	LS	
Category	Earthen Levee			GPS Latitude/Longitude		
				Start		End
Item	Animal Control			37.915195 °		37.915052 °
				-121.322930 °		-121.323430 °
DWR ID	DWR_RD0524_01_f_2016_219					
Comment Code						
A1 : Exterminate rodents and backfill and compact or grout burrows.						
Inspector Comment						
Several large rodent holes on landside slope.

Looking south at several rodent holes on landward slope.

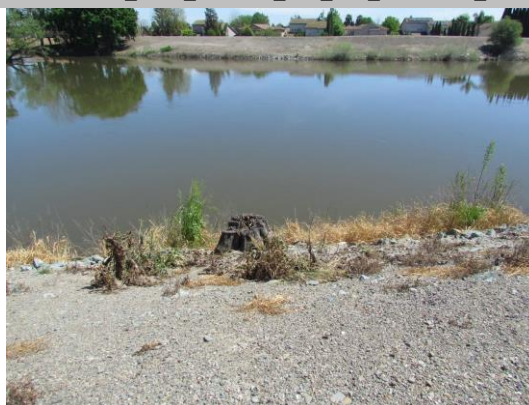
Photo 1 of 1 : SP\_2019\_RD0524\_107\_161\_20190313\_00169.jpg

LM Start	2.91	Rating **	U	Issue No.	161
LM End	2.91	Issue Type +	Ma	Location *	WS
Category	Earthen Levee			GPS Latitude/Longitude	
				Start	End
Item	Trim / Thin Trees			37.913733 °	37.913733 °
				-121.324398 °	-121.324398 °
DWR ID	DWR_RD0524_01_s_2017_161				
Comment Code					
T5 : Tree stumps.					
Inspector Comment

Looking east at large tree stump on waterward shoulder.

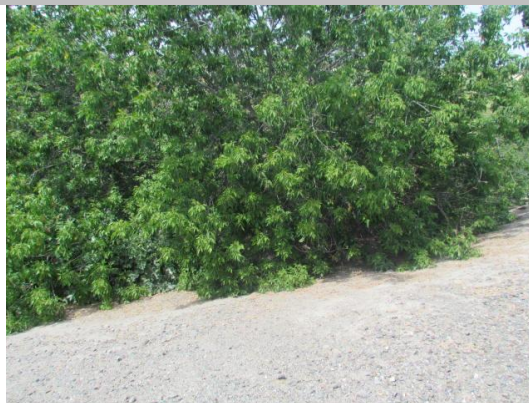
Photo 2 of 2 : SP\_2019\_RD0524\_107\_51\_20190313\_00072.jpg

LM Start	2.93	Rating **	U	Issue No.	51 (cont)	
LM End	2.93	Issue Type +	Ma	Location *	LS	
Category	Earthen Levee			GPS Latitude/Longitude		
				Start		End
Item	Trim / Thin Trees			37.913415 °		37.913389 °
				-121.324503 °		-121.324440 °
DWR ID	DWR_RD0524_01_s_2012_51					
Comment Code						
T1 : Trim trees to at least five feet above ground level.						
Inspector Comment						
Untrimmed trees on landside slope and toe.

Looking south at dense trees on landward slope spring 2015

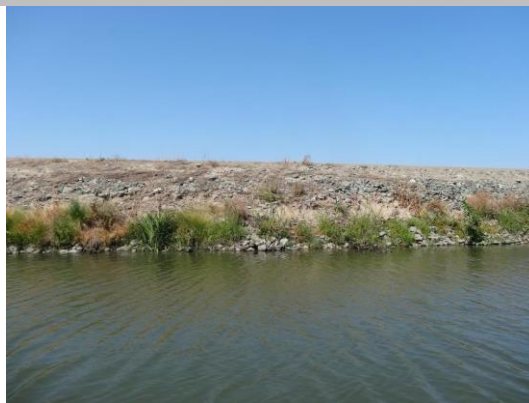
Photo 1 of 4 : SP\_2019\_RD0524\_107\_71\_20190313\_00098.jpg

LM Start	2.96	Rating **	U	Issue No.	71
LM End	2.96	Issue Type +	Ma	Location *	WS
Category	Supplemental			GPS Latitude/Longitude	
				Start	End
Item	DWR Erosion Survey			37.913010 °	37.913010 °
				-121.324490 °	-121.324490 °
DWR ID	RD0524U01RM43.52				
Comment Code					
Inspector Comment					
09/13/2017: A new pocket erosion observed at the eroison site, next to an irrigation pipe.					
07/25/2016: No significant change observed.					
06/24/2015: No significant change observed.					
06/19/2014: No significant change observed.					
08/13/2013: No significant change observed.					
08/07/2012: The site was first reported in 2012 spring levee inspection report. [2017 Site ID:RD0524U01RM43.52]

Front view of the erosion.

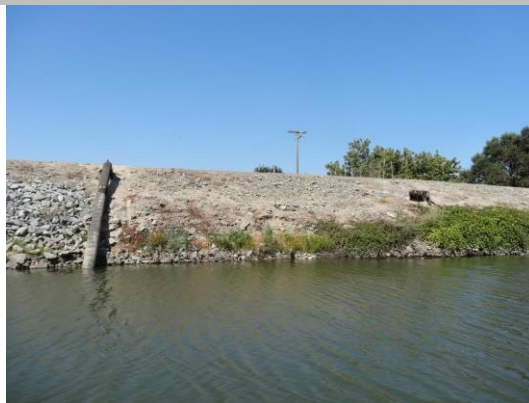
Photo 2 of 4 : SP\_2019\_RD0524\_107\_71\_20190313\_00099.jpg

LM Start	2.96	Rating **	U	Issue No.	71 (cont)	
LM End	2.96	Issue Type +	Ma	Location *	WS	
Category	Supplemental			GPS Latitude/Longitude		
				Start	End	
Item	DWR Erosion Survey			37.913010	°	37.913010
				-121.324490	°	-121.324490
DWR ID	RD0524U01RM43.52					
Comment Code						
Inspector Comment						
09/13/2017: A new pocket erosion observed at the eroison site, next to an irrigation pipe.						
07/25/2016: No significant change observed.						
06/24/2015: No significant change observed.						
06/19/2014: No significant change observed.						
08/13/2013: No significant change observed.						
08/07/2012: The site was first reported in 2012 spring levee inspection report. [2017 Site ID:RD0524U01RM43.52]

View of the newly developed pocket erosion next to an irrigation pipe.

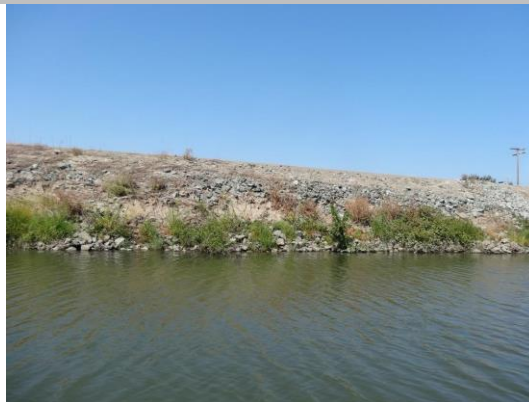
Photo 3 of 4 : SP\_2019\_RD0524\_107\_71\_20190313\_00100.jpg

Close view of the erosion.

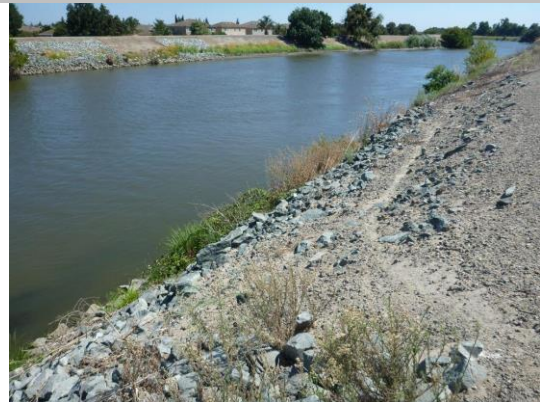
Photo 1 of 2 : LEVAL\_SP\_2019\_465\_2231.jpg

LM Start	2.96	Rating **	A/W	Issue No.	227
LM End		Issue Type +	Ma	Location *	
Category	Supplemental			GPS Latitude/Longitude	
				Start	End
Item	2017 Storm Damage		37.912900 °	°	
			-121.324400 °	°	
DWR ID	DWR_RD0524_01_f_2017_227

Comment Code					
Inspector Comment					
Levee Evaluation Comments					
Description:Slope protection repairs are needed along the waterside slope due to erosion. Based upon levee inspections, it was determined the waterside levee slopes were eroding, deteriorating and degrading in concave pocket sections at various locations along this levee reach. The eroded levee sections need to be restored back to design standards to prevent further deterioration of the damaged levee sections.					
Site ID No:465					
Site Designation:LMA-292					
Repair Type: Erosion					
Rating:Area of Concern					
Field Date:7/26/2017					
Notes: Lower priority because erosion is within rip rap, is only present on lower slope and is not too deep. Levee is narrow here.

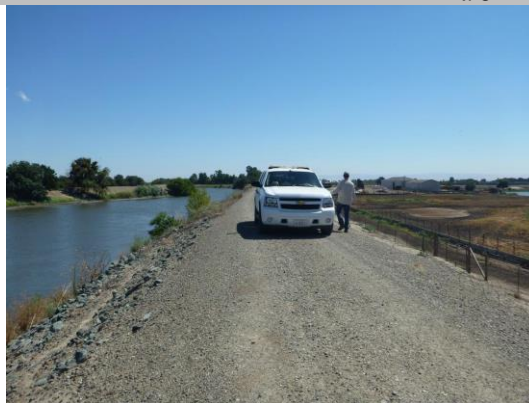
Photo 2 of 2 : LEVAL\_SP\_2019\_465\_2232.jpg

Item	2017 Storm Damage			37.912900 °	°
				-121.324400 °	°
DWR ID	DWR_RD0524_01_f_2017_227				
Comment Code					
Inspector Comment					
<p>Levee Evaluation Comments</p> <p>Description: Slope protection repairs are needed along the waterside slope due to erosion. Based upon levee inspections, it was determined the waterside levee slopes were eroding, deteriorating and degrading in concave pocket sections at various locations along this levee reach. The eroded levee sections need to be restored back to design standards to prevent further deterioration of the damaged levee sections.</p> <p>Site ID No: 465</p> <p>Site Designation: LMA-292</p> <p>Repair Type: Erosion</p> <p>Rating: Area of Concern</p> <p>Field Date: 7/26/2017</p> <p>Notes: Lower priority because erosion is within rip rap, is only present on lower slope and is not too deep. Levee is narrow here.</p>

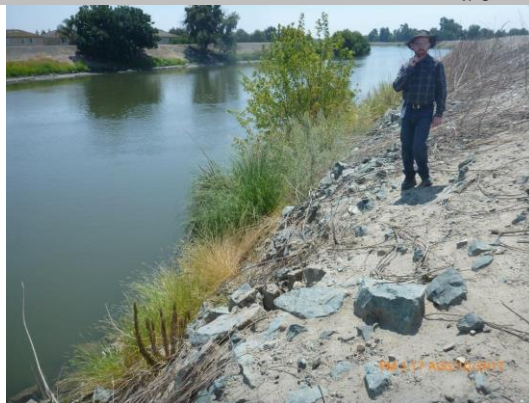
Photo 1 of 3 : LEVAL\_SP\_2019\_529\_4187.jpg

LM Start	2.99	Rating **	A/W	Issue No.	228
LM End	3.01	Issue Type +	Ma	Location *	
Category	Supplemental			GPS Latitude/Longitude	
				Start	End
Item	2017 Storm Damage			37.912500 °	37.912300 °
				-121.324700 °	-121.324700 °
DWR ID	DWR_RD0524_01_f_2017_228				
Comment Code					
Inspector Comment					
Levee Evaluation Comments					
Description:Slope protection repairs are needed along the waterside slope due to erosion and riprap displacement from high water. Based upon levee inspections, it was determined the waterside levee slope is eroding, deteriorating, and degrading. The eroded levee sections need to be restored back to design standards to prevent further deterioration and damage.					
Site ID No:529					
Site Designation:LMA-435					
Repair Type: Erosion					
Rating:Area of Concern					
Field Date:8/10/2017					
Notes:

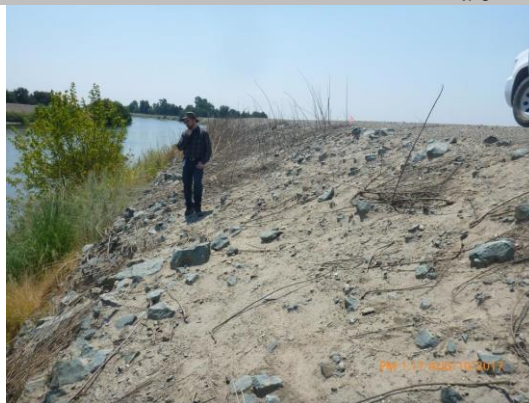
Photo 3 of 3 : LEVAL\_SP\_2019\_529\_4189.jpg

LM Start	2.99	Rating **	A/W	Issue No.	228 (cont)
LM End	3.01	Issue Type +	Ma	Location *	
Category	Supplemental			GPS Latitude/Longitude	
				Start	End
Item	2017 Storm Damage			37.912500 °	37.912300 °
				-121.324700 °	-121.324700 °
DWR ID	DWR_RD0524_01_f_2017_228				
Comment Code					
Inspector Comment					
Levee Evaluation Comments					
Description:Slope protection repairs are needed along the waterside slope due to erosion and riprap displacement from high water. Based upon levee inspections, it was determined the waterside levee slope is eroding, deteriorating, and degrading. The eroded levee sections need to be restored back to design standards to prevent further deterioration and damage.					
Site ID No:529					
Site Designation:LMA-435					
Repair Type: Erosion					
Rating:Area of Concern					
Field Date:8/10/2017					
Notes:

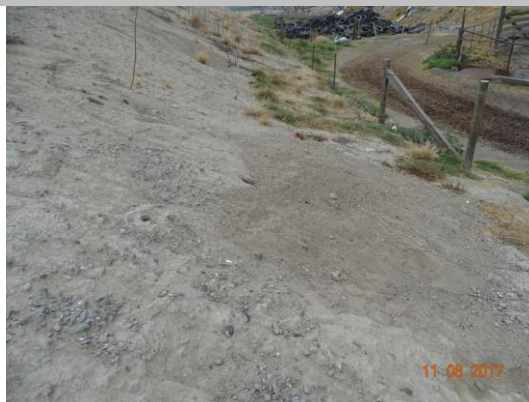
Photo 1 of 3 : SP\_2019\_RD0524\_107\_925\_20190313\_00289.jpg

LM Start	3.07	Rating **	M	Issue No.	925
LM End	3.27	Issue Type +	Ma	Location *	LS
Category	Earthen Levee			GPS Latitude/Longitude	
				Start	End
Item	Animal Control			37.911382 °	37.908602 °
				-121.324928 °	-121.325395 °
DWR ID	DWR_RD0524_01_s_2012_925				
Comment Code					
A1 : Exterminate rodents and backfill and compact or grout burrows.					
Inspector Comment					
Several rodent holes on levee slopes.

Looking southwest at the landside slope.

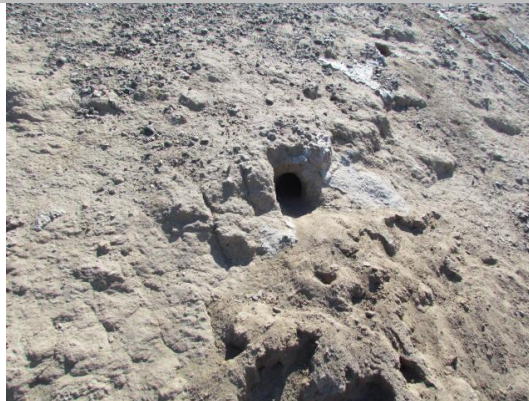
Photo 2 of 3 : SP\_2019\_RD0524\_107\_925\_20190313\_00290.jpg

LM Start	<b>3.07</b>	Rating **	M	Issue No.	<b>925 (cont)</b>
LM End	<b>3.27</b>	Issue Type +	Ma	Location *	LS

Looking at typical view of rodent hole with this section fall 2015.

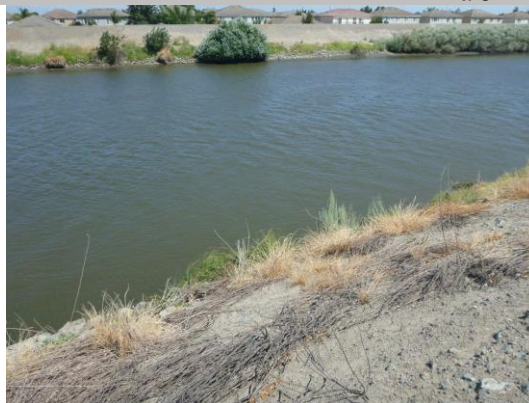
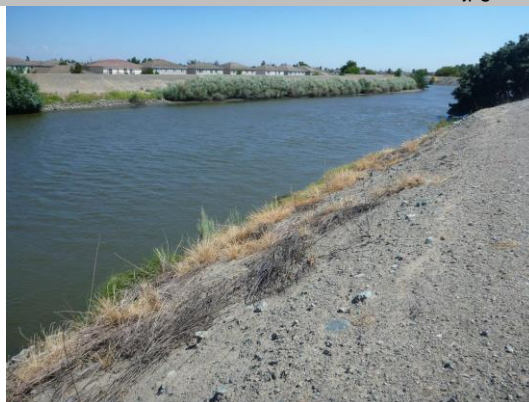
Photo 1 of 2 : LEVAL\_SP\_2019\_466\_2228.jpg

LM Start	3.23	Rating **	A/W	Issue No.	229
LM End		Issue Type +	Ma	Location *	
Category	Supplemental			GPS Latitude/Longitude	
				Start	End
Item	2017 Storm Damage			37.909200 °	°
				-121.325300 °	°
DWR ID	DWR_RD0524_01_f_2017_229

Comment Code					
Inspector Comment					
Levee Evaluation Comments					
Description:Slope protection repairs are needed along the waterside slope due to erosion. Based upon levee inspections, it was determined the waterside levee slopes were eroding, deteriorating and degrading in concave pocket sections at various locations along this levee reach. The eroded levee sections need to be restored back to design standards to prevent further deterioration of the damaged levee sections.					
Site ID No:466					
Site Designation:LMA-293					
Repair Type: Erosion					
Rating:Area of Concern					
Field Date:7/26/2017					
Notes: Lower priority because damage is only on the lower 1/5 of slope. The slopes US and DS are rockd. Levee is narrow here.

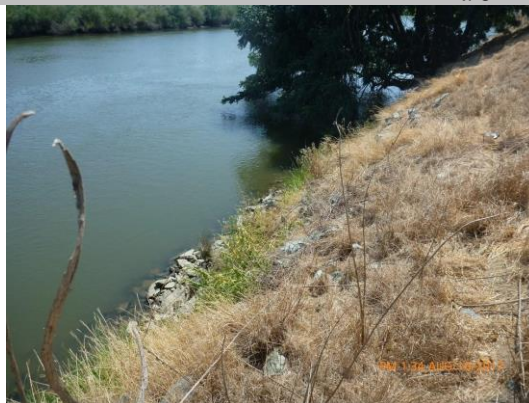
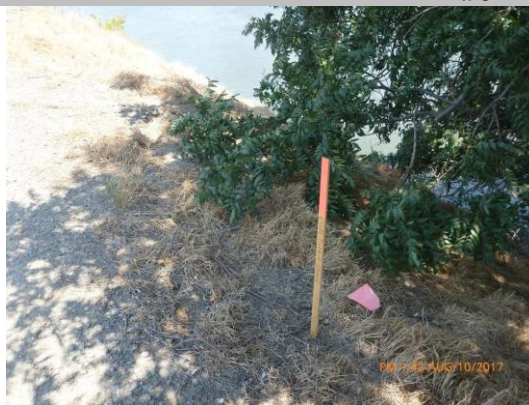
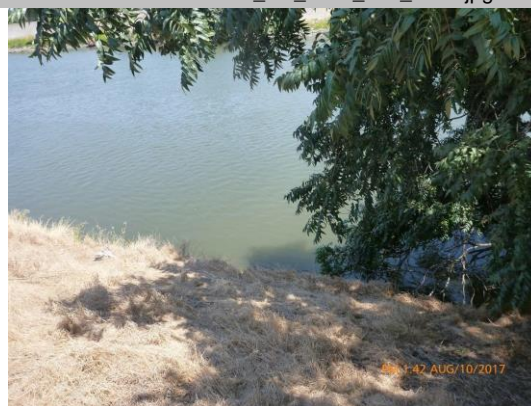
Photo 1 of 3 : LEVAL\_SP\_2019\_528\_4193.jpg

LM Start	3.26	Rating **	A/W	Issue No.	230
LM End	3.26	Issue Type +	Ma	Location *	
Category	Supplemental			GPS Latitude/Longitude	
				Start	End
Item	2017 Storm Damage			37.908800 °	37.908700 °
				-121.325400 °	-121.325300 °
DWR ID	DWR_RD0524_01_f_2017_230				
Comment Code					
Inspector Comment					
Levee Evaluation Comments					
Description:Slope protection repairs are needed along the waterside slope due to erosion and riprap displacement from high water. Based upon levee inspections, it was determined the waterside levee slope is eroding, deteriorating, and degrading. The eroded levee sections need to be restored back to design standards to prevent further deterioration and damage.					
Site ID No:528					
Site Designation:LMA-434					
Repair Type: Erosion					
Rating:Area of Concern					
Field Date:8/10/2017					
Notes: combined with LMA-433

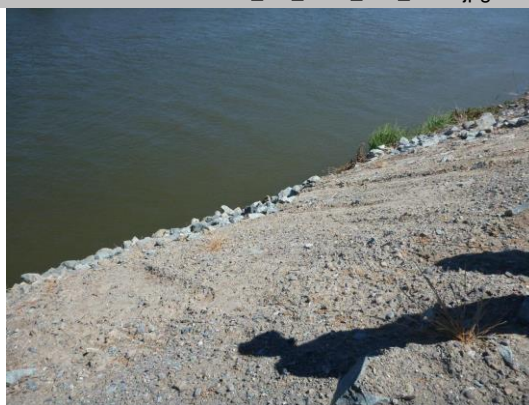
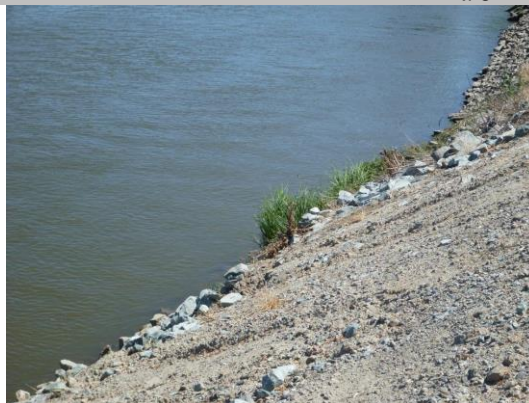
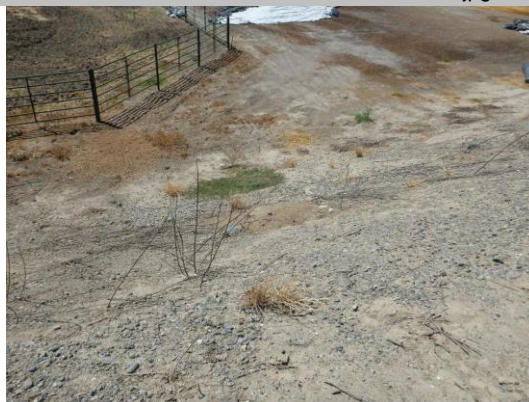
Photo 1 of 3 : LEVAL\_SP\_2019\_467\_2223.jpg

LM Start	3.30	Rating **	A/W	Issue No.	232
LM End		Issue Type +	Ma	Location *	
Category	Supplemental			GPS Latitude/Longitude	
				Start	End
Item	2017 Storm Damage			37.908200 °	°
				-121.325300 °	°
DWR ID	DWR_RD0524_01_f_2017_232

Comment Code					
Inspector Comment					
Levee Evaluation Comments					
Description:Slope protection repairs are needed along the waterside slope due to erosion. Based upon levee inspections, it was determined the waterside levee slopes were eroding, deteriorating and degrading in concave pocket sections at various locations along this levee reach. The eroded levee sections need to be restored back to design standards to prevent further deterioration of the damaged levee sections.					
Site ID No:467					
Site Designation:LMA-294					
Repair Type: Erosion					
Rating:Area of Concern					
Field Date:7/26/2017					
Notes: It looks like new rip rap was placed on the lower 1/4 of the slope. There is a 2-3 ft scarp above the rip rap.

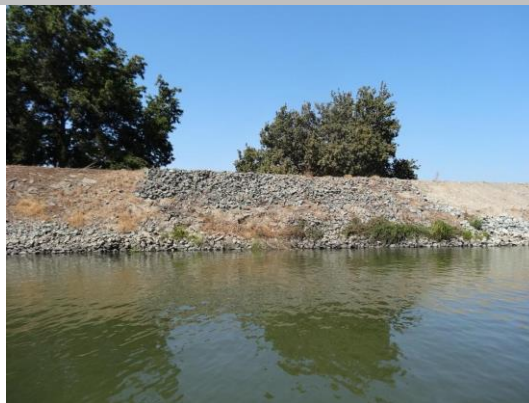
Photo 1 of 4 : SP\_2019\_RD0524\_107\_79\_20190313\_00108.jpg

LM Start	3.30	Rating **	A/W	Issue No.	79
LM End	3.32	Issue Type +	Ma	Location *	WS
Category	Supplemental			GPS Latitude/Longitude	
				Start	End
Item	DWR Erosion Survey			37.908090 °	37.908090 °
				-121.325090 °	-121.325090 °
DWR ID	RD0524U01RM43.86				
Comment Code					
Inspector Comment					
09/13/2017: No significant change observed.					
07/25/2016: No significant change observed.					
06/24/2015: No significant change observed.					
06/19/2014: No significant change observed.					
08/13/2013: The levee toe seems to have been protected by river rocks and vegetation on site. [2017 Site ID:RD0524U01RM43.86]

Front View of the erosion.

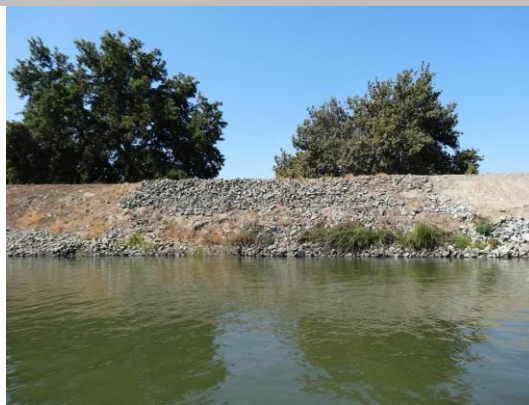
Photo 2 of 4 : SP\_2019\_RD0524\_107\_79\_20190313\_00109.jpg

Front view of the erosion.

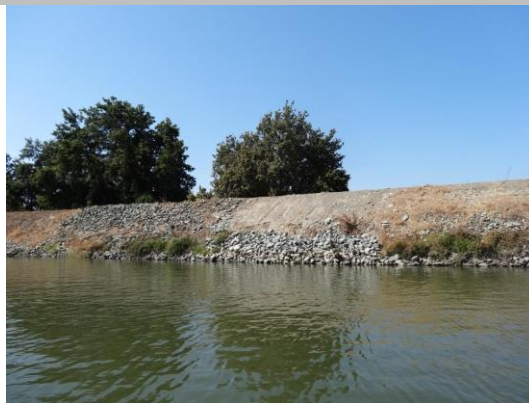
Photo 4 of 4 : SP\_2019\_RD0524\_107\_79\_20190313\_00111.jpg

LM Start	3.30	Rating **	A/W	Issue No.	79 (cont)
LM End	3.32	Issue Type +	Ma	Location *	WS
Category	Supplemental			GPS Latitude/Longitude	
				Start	End
Item	DWR Erosion Survey			37.908090 °	37.908090 °
				-121.325090 °	-121.325090 °
DWR ID	RD0524U01RM43.86				
Comment Code					
Inspector Comment					
09/13/2017: No significant change observed.					
07/25/2016: No significant change observed.					
06/24/2015: No significant change observed.					
06/19/2014: No significant change observed.					
08/13/2013: The levee toe seems to have been protected by river rocks and vegetation on site. [2017 Site ID:RD0524U01RM43.86]

Front View of the erosion.

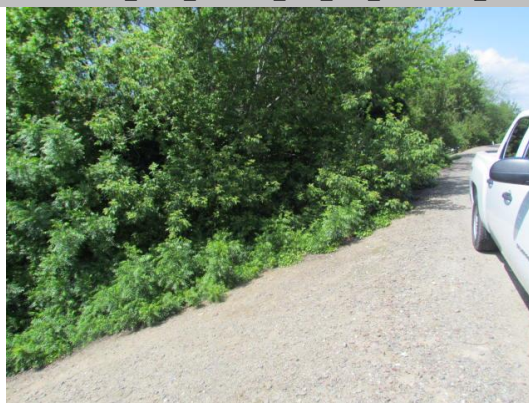
Photo 1 of 2 : SP\_2019\_RD0524\_107\_926\_20190313\_00292.jpg

LM Start	3.30	Rating **	M	Issue No.	926
LM End	3.37	Issue Type +	Ma	Location *	LS
Category	Earthen Levee			GPS Latitude/Longitude	
				Start	End
Item	Trim / Thin Trees			37.908158 °	37.907112 °
				-121.325418 °	-121.325350 °
DWR ID	DWR_RD0524_01_s_2012_926				
Comment Code					
T1 : Trim trees to at least five feet above ground level.					
Inspector Comment

Looking southwest at dense veg on landward slope.

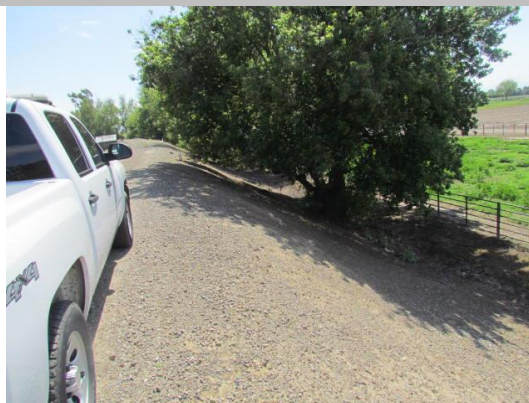
Photo 2 of 2 : SP\_2019\_RD0524\_107\_926\_20190313\_00293.jpg

Looking at untrimmed trees on landward slope and toe.

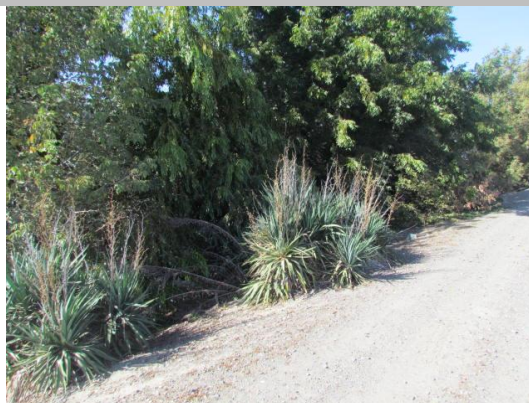
Photo 1 of 1 : SP\_2019\_RD0524\_107\_54\_20190313\_00074.jpg

LM Start	3.44	Rating **	U	Issue No.	54
LM End	3.47	Issue Type +	Ma	Location *	LS
Category	Earthen Levee			GPS Latitude/Longitude	
				Start	End
Item	Trim / Thin Trees			37.906291 °	37.906018 °
				-121.324748 °	-121.324300 °
DWR ID	DWR_RD0524_01_s_2012_54				
Comment Code					
T3 : Trim and thin trees to allow visibility of the ground and room to flood fight.					
Inspector Comment					
Dense untrimmed trees on landside slope.

Looking northwest at dense vegetation on landside slope.

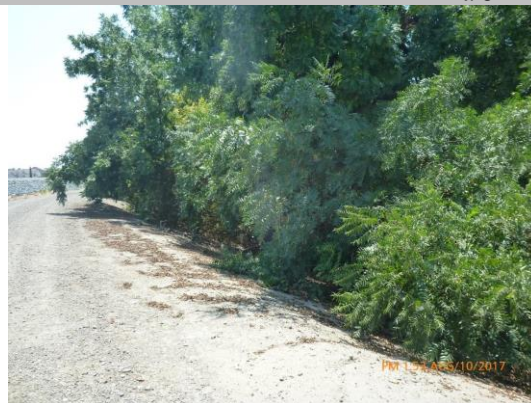
Photo 3 of 3 : LEVAL\_SP\_2019\_526\_4203.jpg

LM Start	3.53	Rating **	A/W	Issue No.	233 (cont)	
LM End	3.54	Issue Type +	Ma	Location *		
Category	Supplemental			GPS Latitude/Longitude		
				Start	End	
Item	2017 Storm Damage			37.905300 °	37.905200 °	
				-121.323800 °	-121.323900 °	
DWR ID	DWR_RD0524_01_f_2017_233					
Comment Code						
Inspector Comment						
Levee Evaluation Comments						
Description:Slope protection repairs are needed along the waterside slope due to erosion and riprap displacement from high water. Based upon levee inspections, it was determined the waterside levee slope is eroding, deteriorating, and degrading. The eroded levee sections need to be restored back to design standards to prevent further deterioration and damage.						
Site ID No:526						
Site Designation:LMA-432						
Repair Type: Erosion						
Rating:Area of Concern						
Field Date:8/10/2017						
Notes:

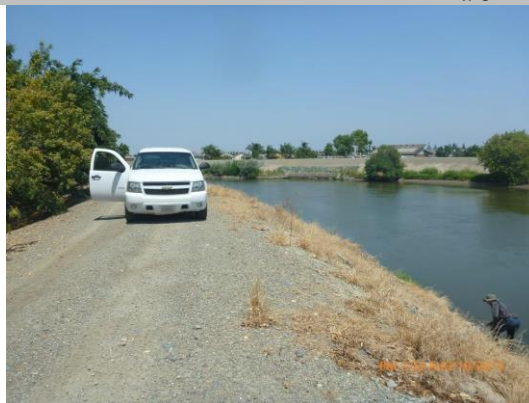
Photo 3 of 3 : LEVAL\_SP\_2019\_525\_4208.jpg

Item	2017 Storm Damage			37.904900 °	37.904800 °	
				-121.323900 °	-121.324100 °	
DWR ID	DWR_RD0524_01_f_2017_234					
Comment Code						
Inspector Comment						
Levee Evaluation Comments						
Description:Slope protection repairs are needed along the waterside slope due to erosion and riprap displacement from high water. Based upon levee inspections, it was determined the waterside levee slope is eroding, deteriorating, and degrading. The eroded levee sections need to be restored back to design standards to prevent further deterioration and damage.						
Site ID No:525						
Site Designation:LMA-431						
Repair Type: Erosion						
Rating:Area of Concern						
Field Date:8/10/2017						
Notes: No appearance of erosion, continue to monitor

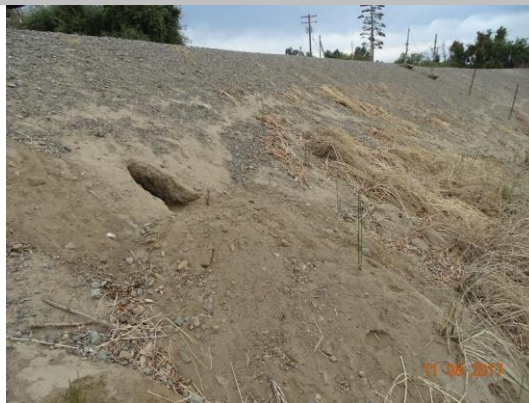
Photo 1 of 1 : SP\_2019\_RD0524\_107\_251\_20190313\_00266.jpg

LM Start	3.67	Rating **	U	Issue No.	251
LM End	3.67	Issue Type +	Ma	Location *	WS
Category	Earthen Levee			GPS Latitude/Longitude	
				Start	End
Item	Animal Control			37.903776 °	37.903776 °
				-121.325323 °	-121.325323 °
DWR ID	DWR_RD0524_01_f_2017_251				
Comment Code					
A3 : No rodents visible, but rodent burrows visible; need to backfill and compact or grout burrows.					
Inspector Comment					
Large rodent holes on both waterside and landside slope.

Looking northwest at the waterside slope.

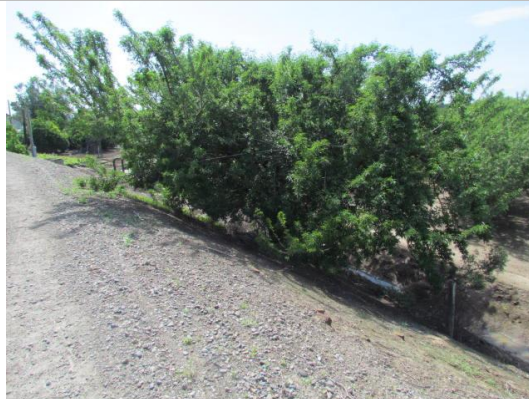
Photo 1 of 1 : SP\_2019\_RD0524\_107\_927\_20190313\_00294.jpg

LM Start	3.77	Rating **	M	Issue No.	927
LM End	3.77	Issue Type +	Ma	Location *	LS
Category	Earthen Levee			GPS Latitude/Longitude	
				Start	End
Item	Trim / Thin Trees			37.902645 °	37.902645 °
				-121.326340 °	-121.326340 °
DWR ID	DWR_RD0524_01_s_2012_927				
Comment Code					
T1 : Trim trees to at least five feet above ground level.					
Inspector Comment					
Untrimmed almond tree on landside slope.

Looking southwest at untrimmed tree at landward toe.

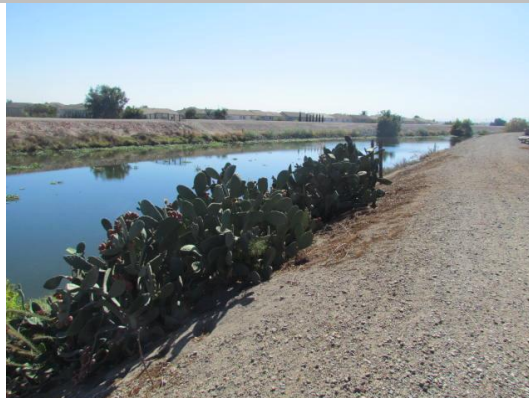
Photo 1 of 2 : SP\_2019\_RD0524\_107\_94\_20190313\_00127.jpg

LM Start	3.89	Rating **	U	Issue No.	94
LM End	3.89	Issue Type +	Ma	Location *	WS
Category	Earthen Levee			GPS Latitude/Longitude	
				Start	End
Item	Vegetation			37.900940 °	37.900940 °
				-121.326414 °	-121.326414 °
DWR ID	DWR_RD0524_01_s_2012_94				
Comment Code					
V2 : Remove the wild growth other than native grasses from the levee slopes.					
Inspector Comment					
Remove cactus from waterside slope.

Looking southeast at cactus on waterward slope fall 2015

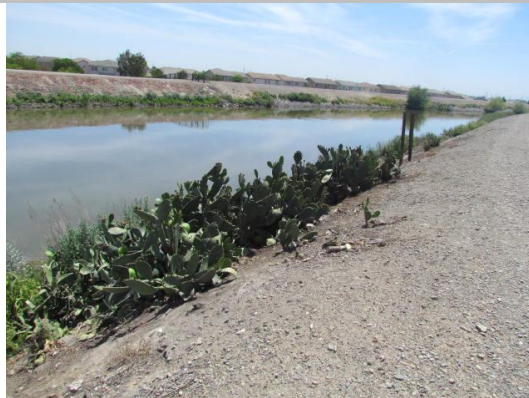
Photo 2 of 2 : SP\_2019\_RD0524\_107\_94\_20190313\_00128.jpg

Looking southeast at cactus on waterside slope. Fall 2013

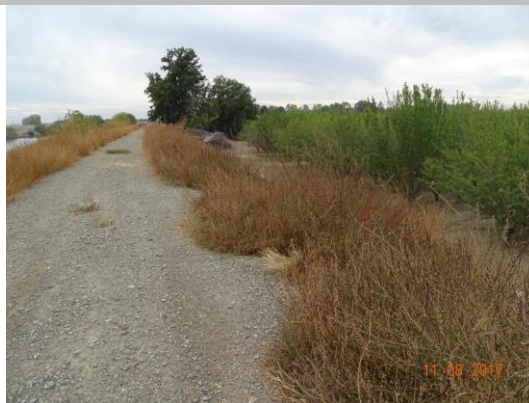
Photo 1 of 1 : SP\_2019\_RD0524\_107\_253\_20190313\_00267.jpg

LM Start	3.97	Rating **	M	Issue No.	253
LM End	4.02	Issue Type +	Ma	Location *	LS
Category	Earthen Levee			GPS Latitude/Longitude	
				Start	End
Item	Vegetation			37.899748 °	37.899116 °
				-121.326596 °	-121.326905 °
DWR ID	DWR_RD0524_01_f_2017_253				
Comment Code					
V2 : Remove the wild growth other than native grasses from the levee slopes.					
Inspector Comment

Looking southwest at the landside slope.

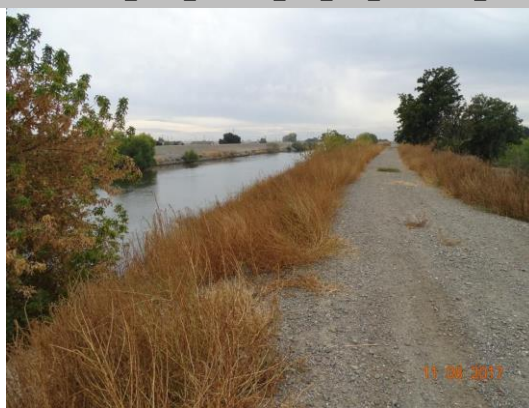
Photo 1 of 1 : SP\_2019\_RD0524\_107\_254\_20190313\_00268.jpg

LM Start	3.97	Rating **	M	Issue No.	254
LM End	4.03	Issue Type +	Ma	Location *	WS
Category	Earthen Levee			GPS Latitude/Longitude	
				Start	End
Item	Vegetation			37.899718 °	37.898945 °
				-121.326605 °	-121.327003 °
DWR ID	DWR_RD0524_01_f_2017_254				
Comment Code					
V2 : Remove the wild growth other than native grasses from the levee slopes.					
Inspector Comment

Looking southwest at the waterside slope.

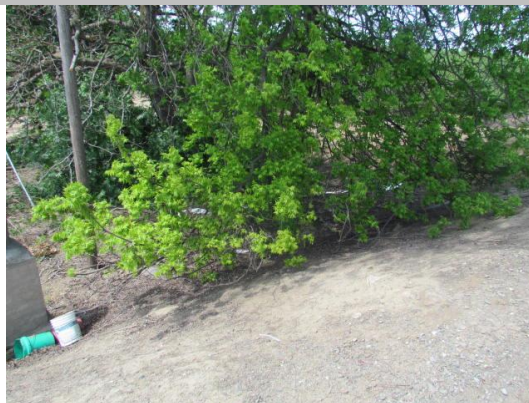
Photo 1 of 1 : SP\_2019\_RD0524\_107\_61\_20190313\_00087.jpg

LM Start	4.03	Rating **	M	Issue No.	61
LM End	4.03	Issue Type +	Ma	Location *	LS
Category	Earthen Levee			GPS Latitude/Longitude	
				Start	End
Item	Trim / Thin Trees			37.898925 °	37.898925 °
				-121.327015 °	-121.327015 °
DWR ID	DWR_RD0524_01_s_2012_61				
Comment Code					
T1 : Trim trees to at least five feet above ground level.					
Inspector Comment

Looking east at untrimmed tree at landward toe.

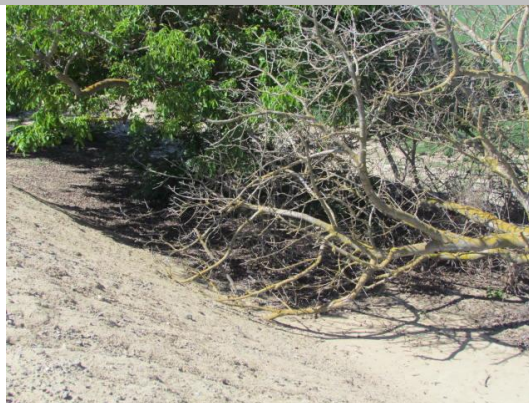
Photo 1 of 1 : SP\_2019\_RD0524\_107\_111\_20190313\_00139.jpg

LM Start	<b>4.38</b>	Rating **	M	Issue No.	<b>111</b>
LM End	<b>4.38</b>	Issue Type +	Ma	Location *	LS
Category	Earthen Levee		GPS Latitude/Longitude		
			Start	End	
Item	Encroachments		37.894258 °	37.894258 °	
			-121.329247 °	-121.329247 °	
DWR ID	DWR_RD0524_01_s_2012_111				
Comment Code					
TR : Tree or limb					
Inspector Comment					
Dead tree at landside toe should be removed from levee toe.

Looking west at dead tree at landside toe.

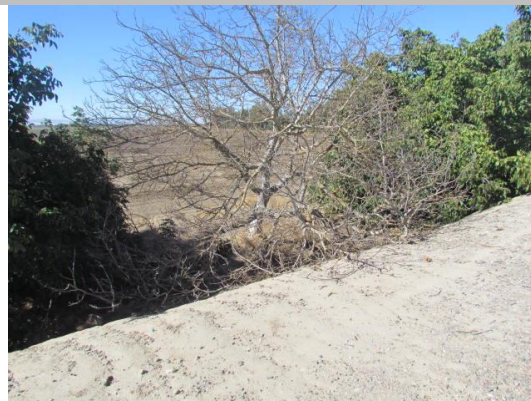
Photo 1 of 1 : SP\_2019\_RD0524\_107\_199\_20190313\_00206.jpg

LM Start	4.43	Rating **	M	Issue No.	199
LM End	4.43	Issue Type +	Ma	Location *	LS
Category	Earthen Levee			GPS Latitude/Longitude	
				Start	End
Item	Encroachments			37.893497 °	37.893497 °
				-121.329049 °	-121.329049 °
DWR ID	DWR_RD0524_01_f_2015_199				
Comment Code					
TR : Tree or limb					
Inspector Comment					
Remove dead tree from landside toe.

Looking west at dead tree on landward slope and toe fall 2015.

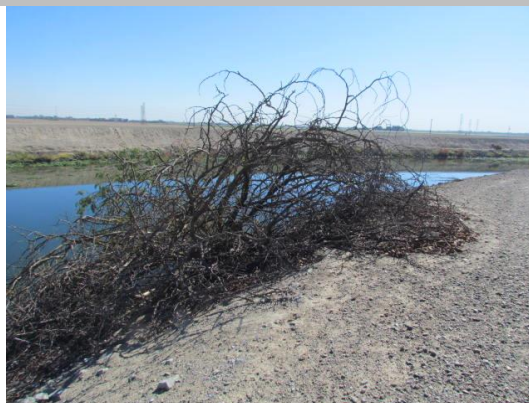
Photo 1 of 2 : SP\_2019\_RD0524\_107\_102\_20190313\_00134.jpg

LM Start	4.52	Rating **	U	Issue No.	102
LM End	4.52	Issue Type +	Ma	Location *	WS
Category	Earthen Levee			GPS Latitude/Longitude	
				Start	End
Item	Encroachments			37.892383 °	37.892383 °
				-121.328194 °	-121.328194 °
DWR ID	DWR_RD0524_01_f_2016_102				
Comment Code					
TR : Tree or limb					
Inspector Comment					
Dead tree on waterside slope.

Looking southeast at dead tree on waterside slope fall 2015

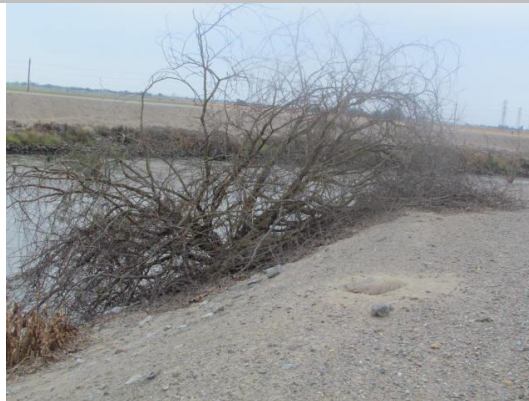
Photo 2 of 2 : SP\_2019\_RD0524\_107\_102\_20190313\_00135.jpg

Looking southeast at dead tree on waterside slope.

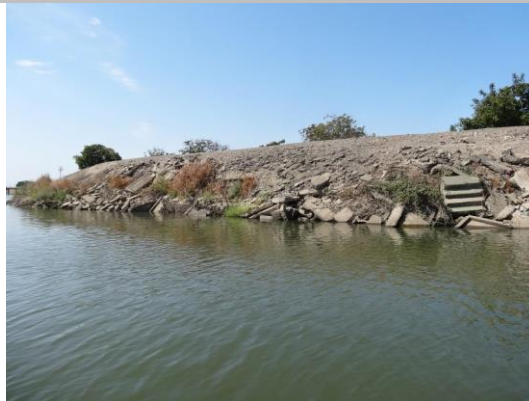
Photo 1 of 3 : SP\_2019\_RD0524\_107\_90\_20190313\_00120.jpg

LM Start	4.53	Rating **	A/W	Issue No.	90
LM End	4.54	Issue Type +	Ma	Location *	WS
Category	Supplemental			GPS Latitude/Longitude	
				Start	End
Item	DWR Erosion Survey			37.892230 °	37.892230 °
				-121.327930 °	-121.327930 °
DWR ID	RD0524U01RM45.07				
Comment Code					
Inspector Comment					
09/13/2017: No significant change observed. 07/25/2016: No significant change observed. 06/24/2015: No significant change observed. 06/19/2014: No significant change observed. 08/13/2013: No significant change observed. 08/07/2012: The erosion is located at the inside of a river bend. Site is covered with broken concrete blocks and other debris. [2017 Site ID:RD0524U01RM45.07]

Front view of the erosion site.

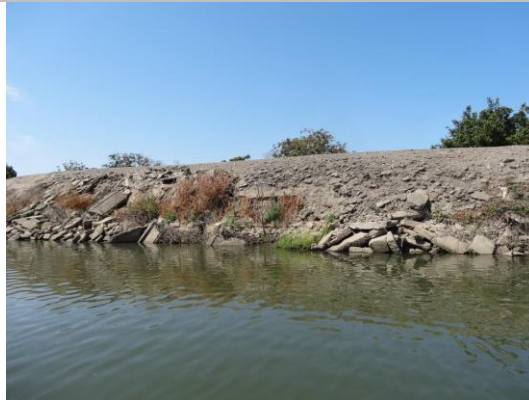
Photo 2 of 3 : SP\_2019\_RD0524\_107\_90\_20190313\_00121.jpg

Close view of the site.

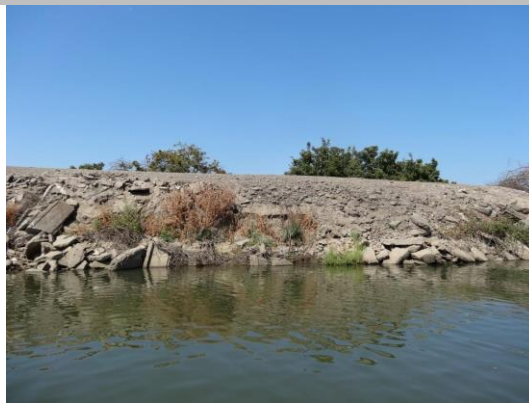
Photo 3 of 3 : SP\_2019\_RD0524\_107\_90\_20190313\_00122.jpg

LM Start	4.53	Rating **	A/W	Issue No.	90 (cont)	
LM End	4.54	Issue Type +	Ma	Location *	WS	
Category	Supplemental			GPS Latitude/Longitude		
				Start	End	
Item	DWR Erosion Survey			37.892230 °	37.892230 °	
				-121.327930 °	-121.327930 °	
DWR ID	RD0524U01RM45.07					
Comment Code						
Inspector Comment						
09/13/2017: No significant change observed. 07/25/2016: No significant change observed. 06/24/2015: No significant change observed. 06/19/2014: No significant change observed. 08/13/2013: No significant change observed. 08/07/2012: The erosion is located at the inside of a river bend. Site is covered with broken concrete blocks and other debris. [2017 Site ID:RD0524U01RM45.07]

Front view of the site. Note the loosely placed concrete blocks at the site.
